### Report Summary

★ Address: 175 E. Wisconsin Avenue, Oconomowoc, Wisconsin 53066

**Claim/File Number: 00311183993**  
**HailTrax Report # 12070**  
**Delivery Date: 12/18/06**

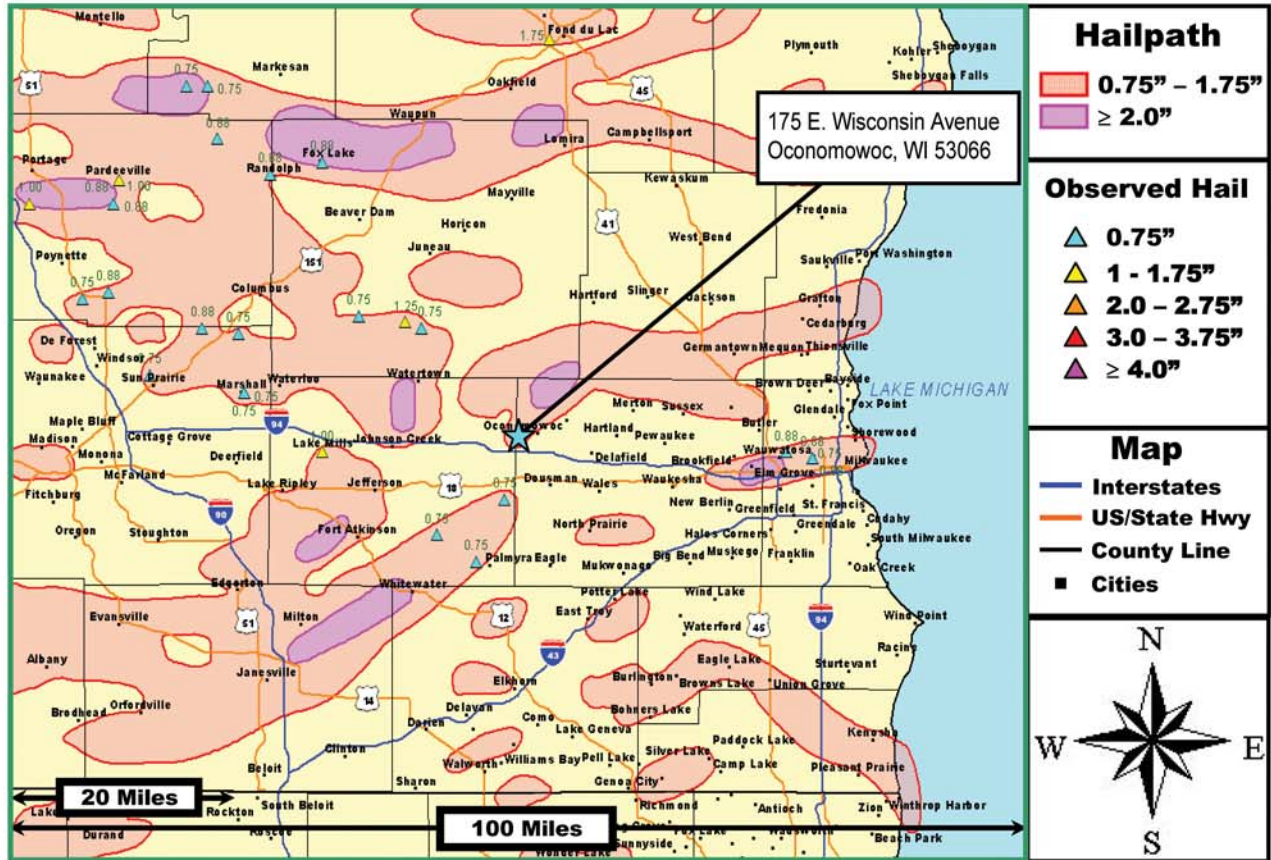
This event is characterized by hailswaths of both large (0.75" to 1.75" diameter) and very large ( $\geq 2"$  in diameter) hail within 50 miles of the location of interest. In addition, hail up to 1.0" in diameter was reported within the 100 mile view shown above. Careful and expert analysis of the radar data indicates that widespread strong storms occurred during the time period of interest. Associated with some of these storms, an analyzed path of large hail with an embedded path of very large hail extends from approximately 2 miles southwest of Oconomowoc, WI east-northeastward to Lake Michigan. The location of interest is within this analyzed path of large hail where the largest hail would potentially have been equal to or greater than 0.75" but less than 2" in diameter.
